SUBJECT: Transmittal of the December 18, 2006 Inspection Checklist for the On-Site Disposal Facility

OSDF Cell Cap Post Closure Inspection Checklist

Date of Inspection: December 18, 2006

On-Site Disposal Facility Inspection Report

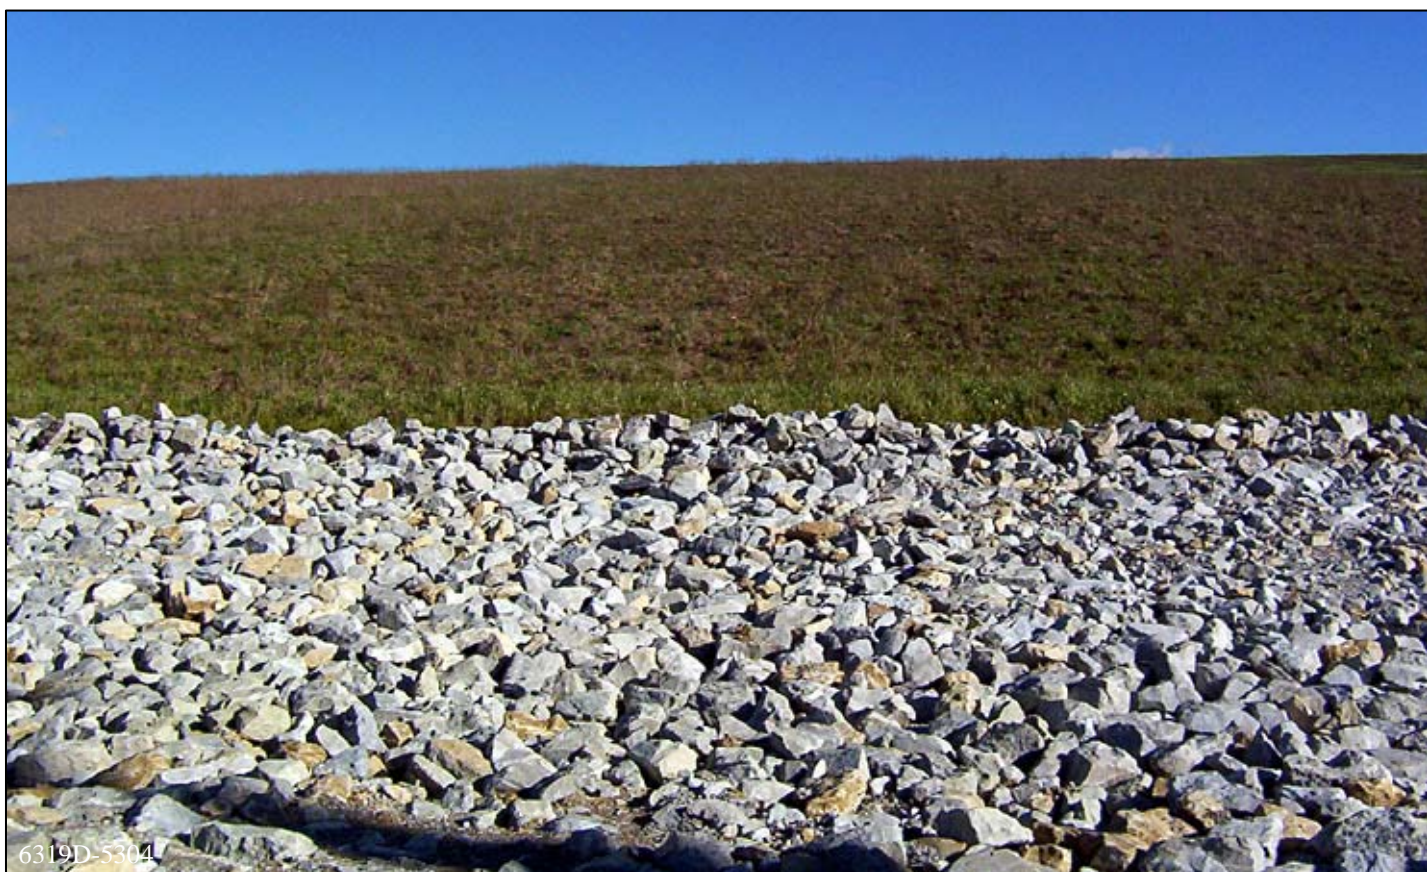
West Face Cell 7

In general, establishment of the vegetative cover is progressing well. Cells 1 through 6 had full stands of grass, and previously-repaired areas have recovered nicely. Erosion is primarily limited to the west side of Cells 7 and 8, where seeding late in the fall did not yet permit an adequate stand of grass to be established. Several bare areas are present, and small mammals have burrowed holes

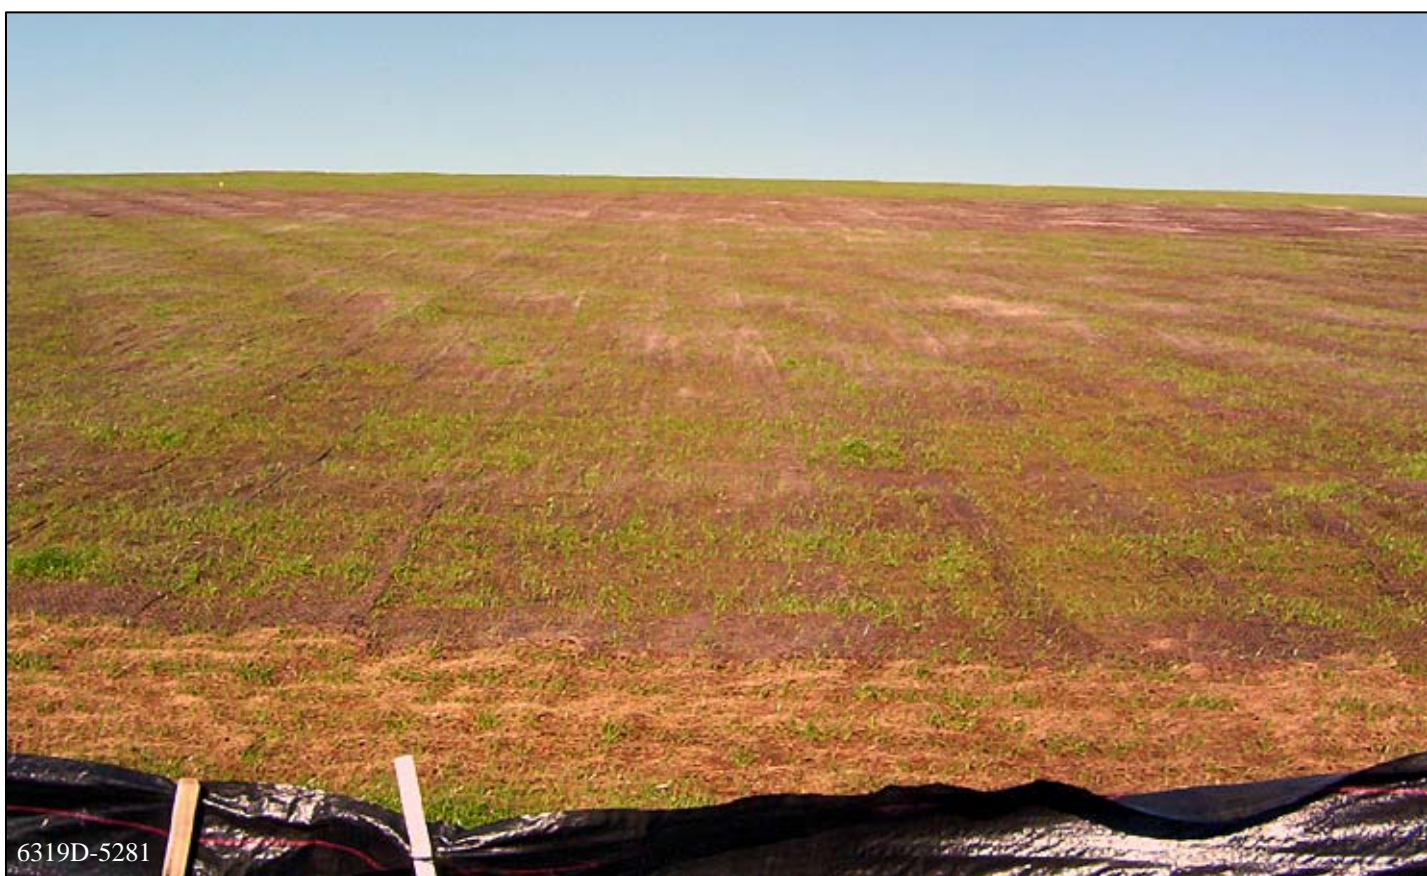
South Face Cell 8

Some concern was raised regarding the uneven surface that was observed along the south side of Cell 8. The uneven surface is a result of the seedbed preparation process, when a soil stabilizer is used to break up compacted soil. Tire tracks from the stabilizer left a series of depressions at a 45-degree angle to the slope. The concern was that these depressions may accelerate erosion by concentrating flow. After an evaluation of the slope was performed by Geosyntec Consultants, the Office of Legacy Management decided to continue monitoring for erosion and make any repairs that may be necessary in the spring (Reference 1). As stated above, some erosion repair is already needed for the west slope of Cells 7 and 8.
